Manhole Inspection Summary

Manhole # S19GG2071MH

Record Plat: **19GG2** Node: **071** Status: **New Manhole (Not in GIS)** Insp Date: **10/3/06 9:28 AM**

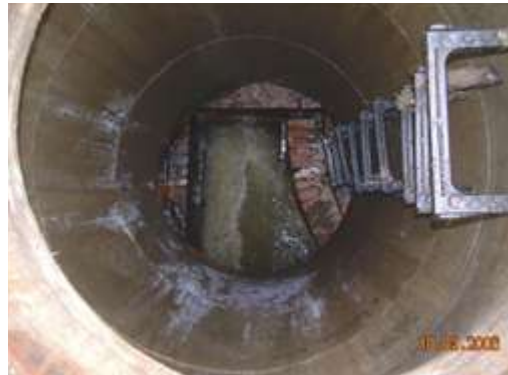
Top View

Frame leaks. Corbel and Barrel infiltration. Evidence of surcharge - Bench debris.

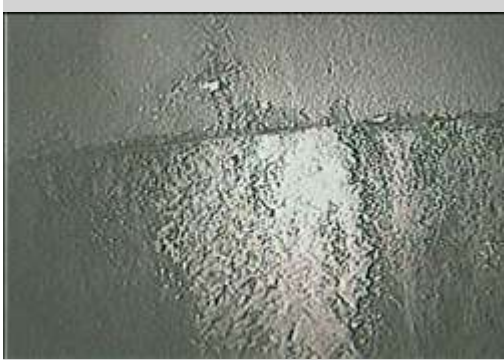
Defect

Barrel infiltration.

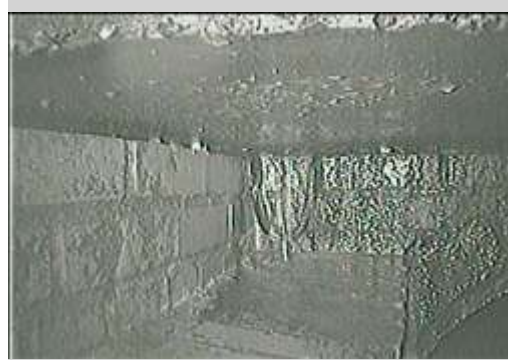
Defect

Barrel root intrusion and infiltration.

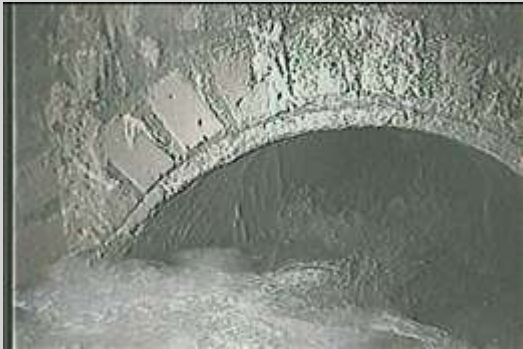
42 in. Circular Gravity Sewer Pipe Out @ 12 O'Clock

Invert Depth: **14.80** (ft.) Flow Characteristics: **Fast**

Infiltration: **None** Pipe Seal Cond: **Unknown**

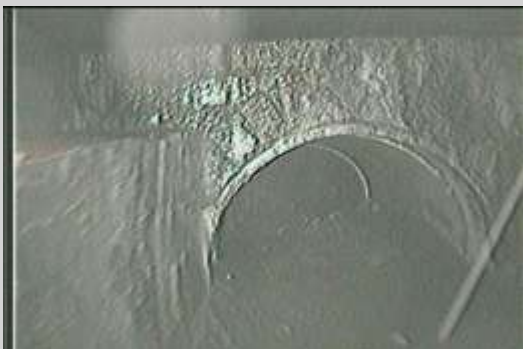
24 in. Circular Gravity Sewer Pipe In @ 5 O'Clock

Infiltration: **Evidence** Pipe Seal Cond: **Unknown**

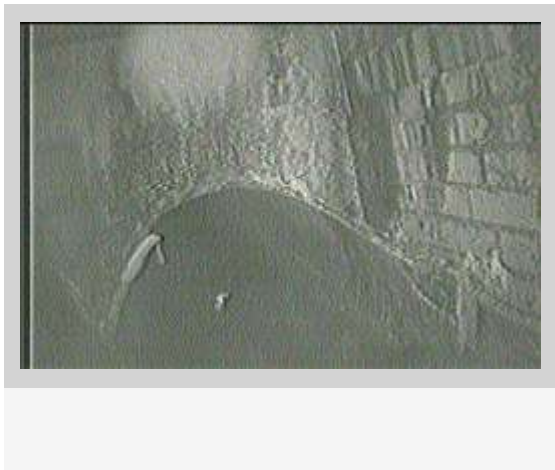
24 in. Circular Gravity Sewer
Pipe In @ 6 O'Clock

Infiltration: **Evidence** Pipe Seal Cond: **Unknown**
